# **OPERATING EXPERIENCE WEEKLY SUMMARY**

**Office of Nuclear and Facility Safety**

**September 17 - September 23, 1999**

**Summary 99-38**

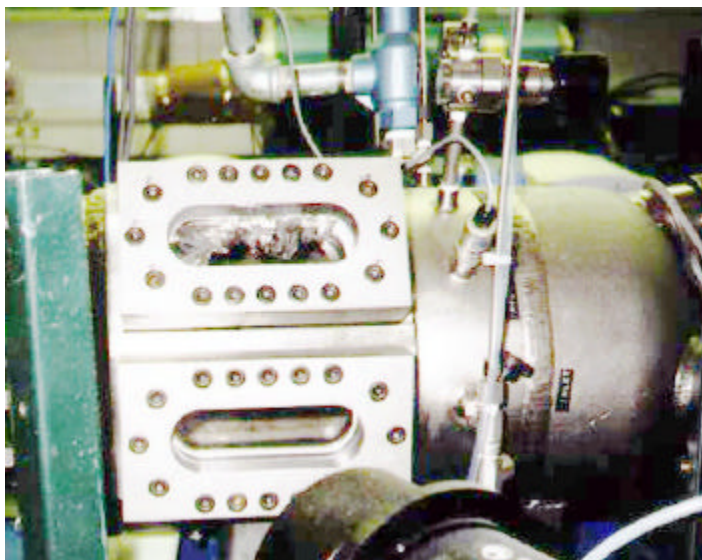
**Figure 1-1. Vessel and Failed Viewing Port**

The pressure vessel, which is a 2-ft long, 1-ft diameter cylinder, has a maximum allowable pressure of 1,100 psi with an operating pressure of 950 psi. The viewing ports are quartz measuring 3 inches by 7 inches and are 1.25 inches thick. They are held in place by metal fittings secured with bolts. The pressure vessel is used to examine the characteristics of diesel fuel aerosols. There was no fuel aerosol in the vessel when the technician pressurized it with nitrogen. Figure 1-1 shows the vessel with the failed viewing port (top).

Investigators determined that the direct cause of the event was personnel error in that the response to the observation of a hazardous condition was inadequate. The researcher was aware that the quartz window had a 1-inch subsurface crack several weeks before the event, but he assumed that the window had been replaced. The technician had also observed the crack when he assembled the window on the day of the incident. Also, communication between the researcher and the technician was not adequate regarding the plan to increase the pressure from a 60-psi test pressure to 900 psi for a subsequent test. The technician communicated his apprehension when the pressure had been increased stepwise to approximately 700 psi, just before the window ruptured. Investigators also learned that the vessel had been operated several times at 950 psi without incident before the crack was observed.

Investigators determined that contributing causes included inadequate procedure/checklist for assembling the windows, the operators' lack of familiarity with the unique design characteristics of the device and its operational requirements, and inadequate design. The vessel has three view ports that penetrate the side of the vessel at different angles to allow for photographic and instrumental analysis of the fuel spray. The vessel also has a removable end plate penetrated by the fuel injector. The American Society of Mechanical Engineers (ASME) certification identified the bolts that secure the end plate to the vessel as the only "removable" bolts. Because the design did not include a dedicated cleaning port for removal of accumulated fuel on the inside surface of the glass, which interferes with optical measurements, the experimenters repeatedly removed and reinstalled one of quartz windows. This practice was not consistent with the design certification and required repeated handling of a vulnerable view port.

A vendor had designed and fabricated the vessel in accordance with ASME code. However, research personnel were not familiar enough with the code to evaluate conformance, and they incorrectly assumed that the scope of the code compliance included the windows. A post-incident evaluation of the design by independent Argonne National Laboratory (ANL) personnel revealed that the design was not consistent with established engineering practices for selection of safety factors for glass windows.
